Field Report for Airborne Data Collected In Support of US EPA Region VI Intercontinental Terminals Company LLC Fire 19 March 2019

Data Results Flight 3, 19 March 2019

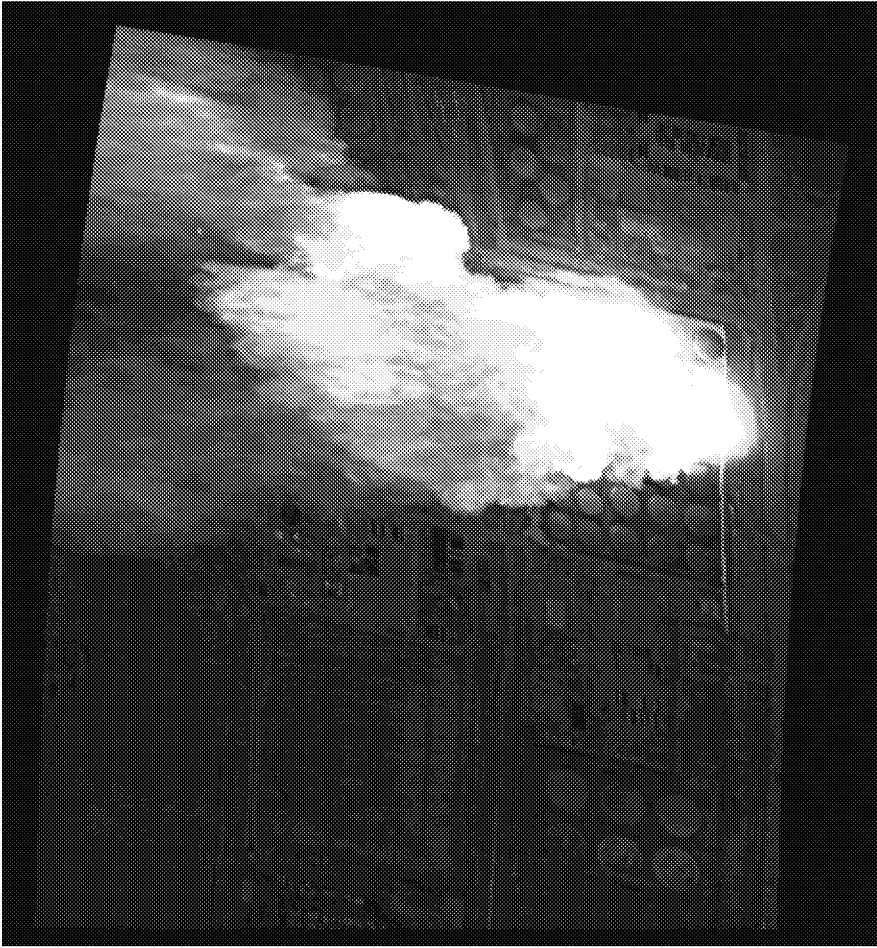
Figure 5: IR image ITC, 19 March 2019, Run 6

A total of 2 test and 8 data passes were made in the proximity of the site and an infrared line scanner images were generated for each pass. Figure 5 shows a typical 3-band infrared image obtained from data collected for Run 6. The overall thermal signature of the fire is very large. A qualitative analysis of the image indicates that the region of total saturation of the detector (white) is roughly 280 meters across (north to south) and about 600 meters in length. As with prior flights almost total obscuration of the ground signal is being masked by heat and/or particulates. Figure 6 shows a comparison of IR data collected on 18 March 2019 (left) and 19 March 2019 (right). The images are roughly scaled to the same size. It is evident that the magnitude of the fire on 19 March 2019 is measurably larger than on previous flights.

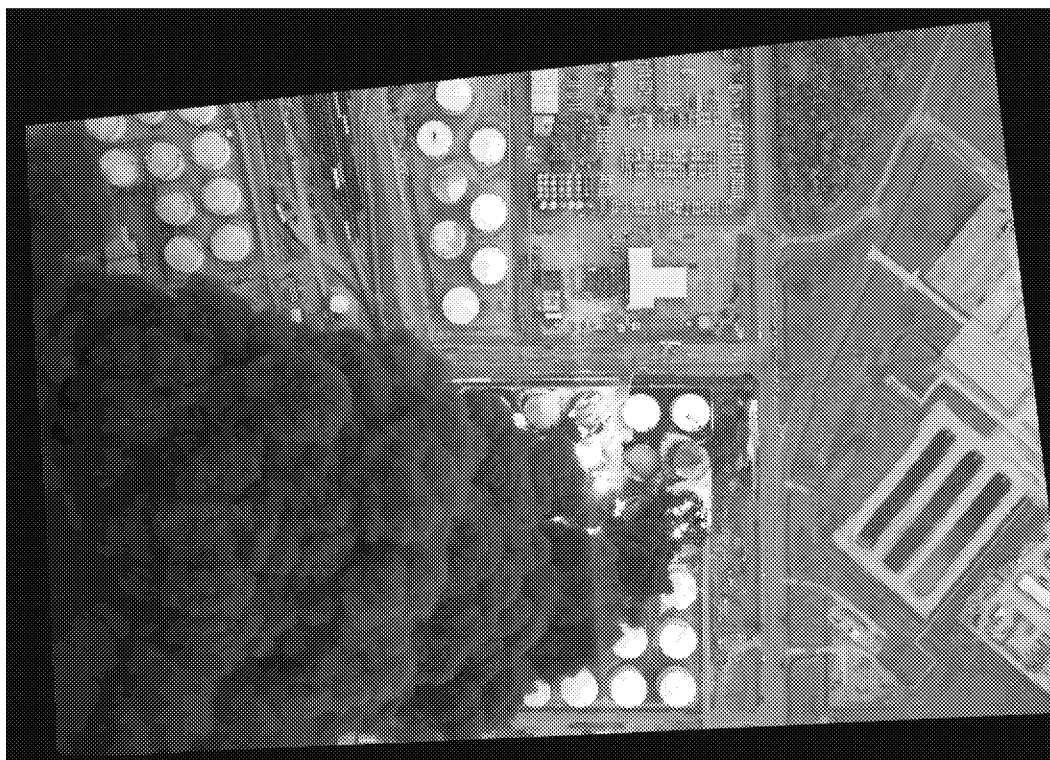
Figure 7: Aerial Image of the ITC Fire, Flight 3

A full set of high resolution aerial digital photography were collected as part of the flight. Figure 7 shows a representative overhead image collected as part of each pass. Figure 8 illustrates a typical oblique image. Both images confirm the finding that the fire is much more involved than on prior days with most of the tanks in the tank farm on fire.
